# **Replacing Table Motion Control Board**

Version 1.0 Date: 1/19/2015

This document will show how to replace the Table Motion Control Board (51-20007-002 Table Motion Control PCBA)

This applies to all mPower series printers.

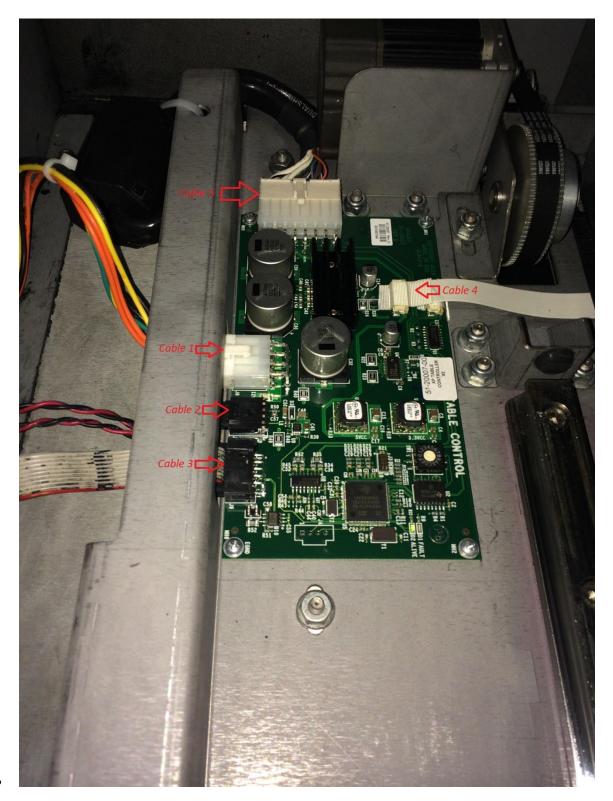
No movement at table. Table Motion Control board not displaying green lights.

- 1. Power down printer from the back.
- 2. Lift hood and unplug the 5 cables from the table board shown in the image below.
  - Cable 1: Lift white tab up in order to disconnect cable from board.
  - Cable 2: Push down black tab in order to disconnect cable from board.
  - Cable 3: Pull the cable to the left to disconnect from board.
  - <u>Cable 4</u>: Lift up the white tape covering the connection and pull the cable to the right to disconnect from board.
  - Cable 5: Lift white tab up in order to disconnect cable from board.

Note: If you find that when performing the automatic height adjustment that the table only moves in/out and NOT up/down, it usually is an indication that the white cable (see Cable 4 in image above) at the right of the table board is not seated properly. If this is the case you'll want to power down printer once more from the back and reseat the white cable connection.
